DESCRIPTIONS

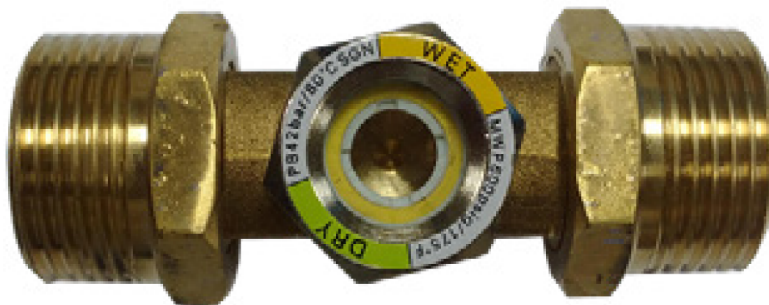
Fig.1201 with connection DN 25, thread BS21 (BSPT)
